**DEPARTMENT OF TRANSPORTATION****DIVISION OF ENGINEERING SERVICES**

Contract #: 04-0120F4Cty: SF/ALA Rte: 80 PM: 13.2/13.9File #: 1.28**WELDING INSPECTION REPORT****Resident Engineer:**Siegenthaler, Peter**Address:** 333 Burma Road**City:** Oakland, CA 94607**Report No:** WIR-019458**Date Inspected:** 18-Jan-2011**Project Name:** SAS Superstructure**OSM Arrival Time:** 630**Prime Contractor:** American Bridge/Fluor Enterprises, a JV**OSM Departure Time:** 1500**Contractor:** American Bridge/Fluor Enterprises, a JV**Location:** Job Site**CWI Name:** See below**CWI Present:** Yes No**Inspected CWI report:** Yes No N/A**Rod Oven in Use:** Yes No N/A**Electrode to specification:** Yes No N/A**Weld Procedures Followed:** Yes No N/A**Qualified Welders:** Yes No N/A**Verified Joint Fit-up:** Yes No N/A**Approved Drawings:** Yes No N/A**Approved WPS:** Yes No N/A**Delayed / Cancelled:** Yes No N/A**Bridge No:** 34-0006**Component:** SAS OBG**Summary of Items Observed:**

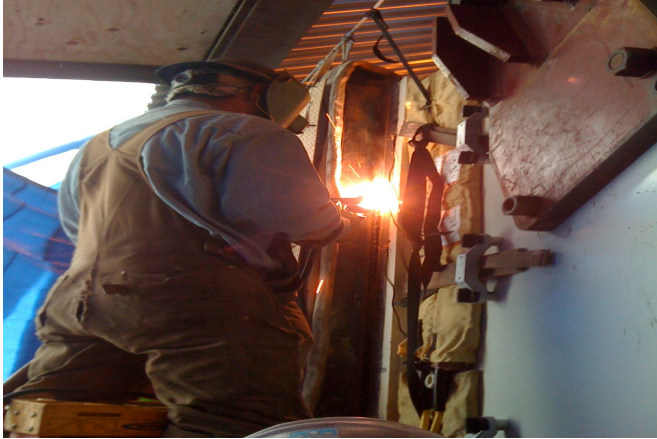
The QA Inspector randomly observed the ABF welder Darcel Jackson performing carbon arc gouging and back grinding of the above identified weld joints. The QA inspector randomly observed the ABF welder grind the back gouged weld joints to bright metal. The QA Inspector randomly observed the back gouged weld joints and noted they appeared to be in general compliance with the contract requirements. The QA Inspector randomly observed the SE QC Inspector Mike Johnson perform magnetic particle testing of the back gouged weld joint and noted no relevant indications were present at the time of the testing. The QA Inspector randomly observed the ABF welder continue welding the in process lift lug hole restoration. The QA Inspector noted the weld joint was approximately 70% complete at the time of the SMAW 4G back weld. The QA Inspector randomly observed the ABF welder continue the SMAW fill pass. The QA Inspector randomly observed the SMAW parameters were 1/8" E7018 low hydrogen electrodes with 125 Amps. The QA Inspector noted the parameters appeared to be in general compliance with ABF-WPS-1070A R1. The QA Inspector randomly observed the ABF welder did complete the above identified lifting lug hole on this date. The QA Inspector noted the weld reinforcement was ground flush on the QA Inspectors shift. The QA Inspector observed the grinding did appear to comply with the contract requirements.
